Road Erosion

LaFourche Parish, LA

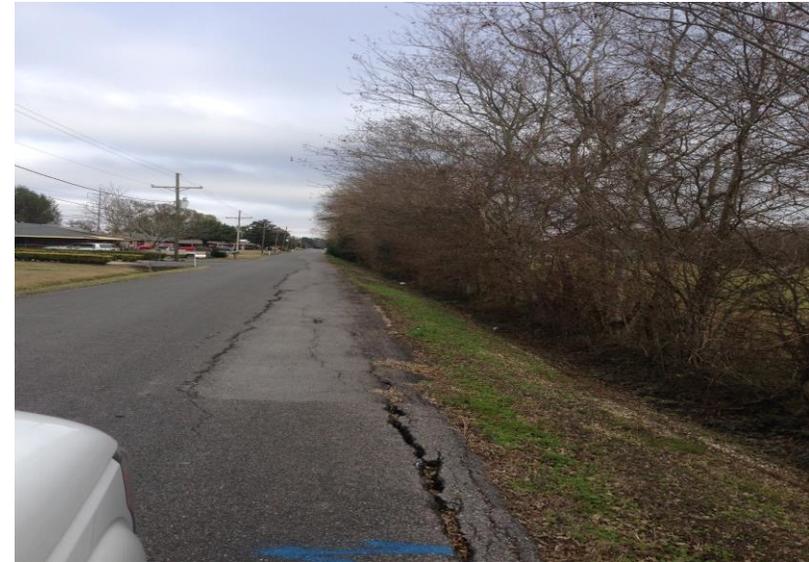
BEFORE

Due to the extreme slope of the land, this road in Lafourche Parish in Louisiana was cracking and sliding down the slope, causing unsafe conditions and resulting in ongoing repair expenses. The problem was corrected using Tidewall TW75 in 10 foot long sheets, with approximately 2 feet of exposed height. This brought the shoulder of the road closer to the elevation of the road itself, relieving the stress on the asphalt and allowing permanent repairs to be made.
